# Manhole Inspection Summary

Manhole # S15II\_011MH

Insp Date: **10/26/07 9:26 AM**

**Location** Address: **REAR 2715 NORTH**

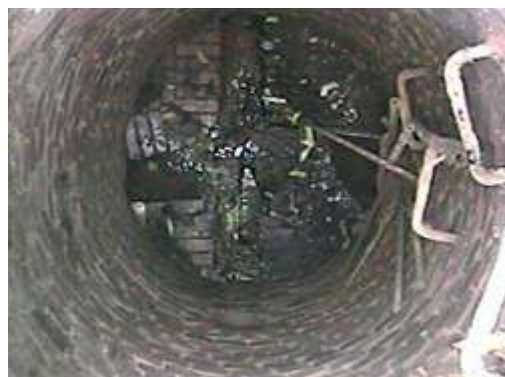
Defect 1

☒ **Evidence Of Surcharge** Depth: **2** (ft.) ☐ Active Surcharge Present

EVIDENCE OF SURCHARGE

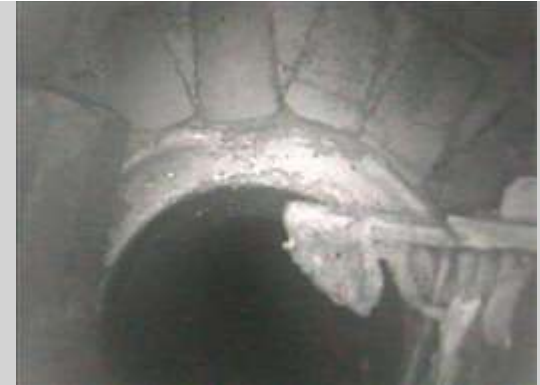
12 O'Clock Outflow

8 in. Circular Gravity Sewer  
Pipe Out @ 12 O'Clock

Pipe Height: (in.) Direct  
Pipe Material: **Clay** ☐ Pipe Lined  
Invert Depth: **9.52** (ft.) Flow Characteristics: **Slow**  
Deposits: ☒ None ☐ Mud ☐ Sludge ☐ Debris ☐ Grease  
Silt Depth: (in.) Deposits Extent:  
Infiltration: **None** Pipe Seal Cond: **Sound**

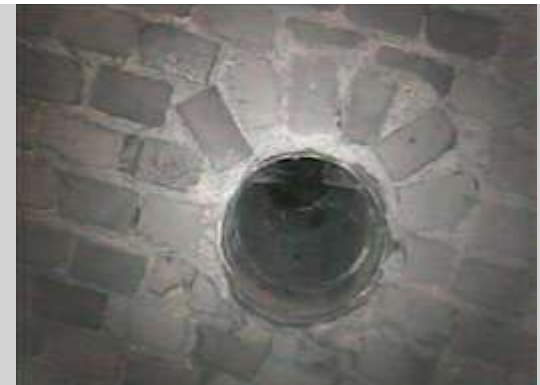
6 O'Clock Inflow

8 in. Circular Gravity Sewer  
Pipe In @ 6 O'Clock

Pipe Height: (in.) Direct  
Pipe Material: **Clay** ☐ Pipe Lined  
Invert Depth: **7.78** (ft.) Flow Characteristics: **Slow**  
Deposits: ☐ None ☐ Mud ☒ Sludge ☒ Debris ☒ Grease  
Silt Depth: **8** (in.) Deposits Extent: **Heavy**  
Infiltration: **None** Pipe Seal Cond: **Sound**

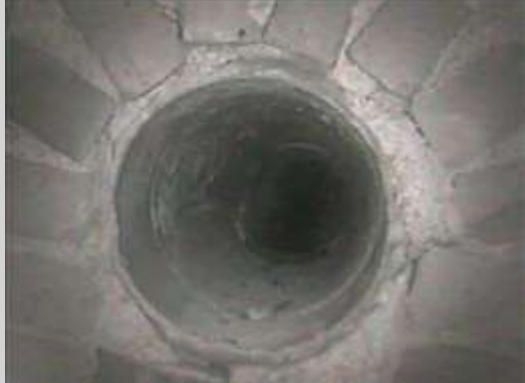
9 O'Clock Inflow

Pipe In @ 9 O'Clock

Pipe Height: (in.) Direct

Pipe Material: **Clay** ☐ Pipe Lined

Invert Depth: **6.38** (ft.) Flow Characteristics: **Slow**

Deposits: ☒ None ☐ Mud ☐ Sludge ☐ Debris ☐ Grease

Infiltration: **None** Pipe Seal Cond: **Sound**

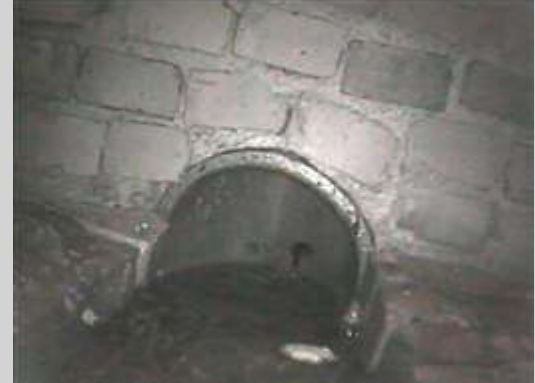
Drop In @ 9 O'Clock

Drop: **Outside** **Direct**

Inv Depth: **9.57** (ft.)

Drop Condition: **Open**
